**Flood Control Project Maintenance
Levee Inspections**

Maintenance Issue Types Only, Levee Inspection Report By Mile - Fall 2015

Reclamation District No. 0817 Carlin

Waterway	Bank	Unit Miles	Inspection Start/End	Inspector
Unit No. 01 South Dry Creek	Left	3.81	11/16/2015 11/16/2015	Jai Lor

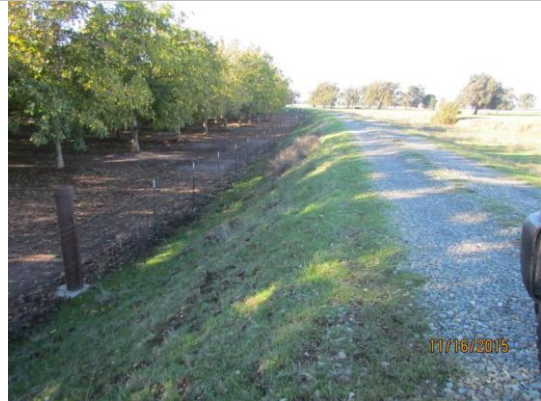
Photo 1 of 1 : FA_2015_RD0817_12_2_20151117_00003.jpg

LM Start	0.00	Rating **	A	Issue No.	2
LM End	3.80	Issue Type +	Ma	Location *	LS
Category	Earthen Levee			GPS Latitude/Longitude	
				Start	End
Item	Vegetation			38.984675 °	39.019703 °
				-121.506107 °	-121.454296 °
DWR ID	DWR_RD0817_01_f _ 2015_2				
Action/Comments					
Control annual grass and weeds on the levee slopes and easements. Inspector Comments: LMA has grazed levee slopes.

View of the vegetation on the landward side of the levee looking downstream. Fall 2015.

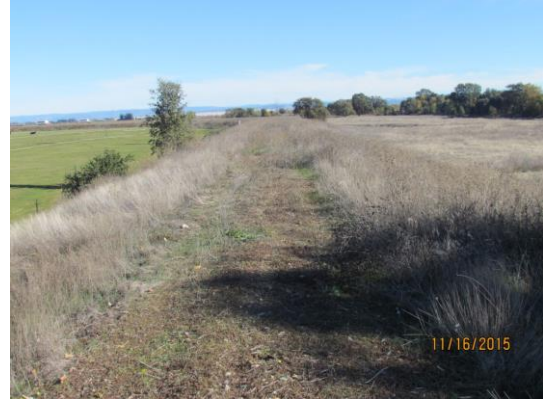
Photo 1 of 1 : FA_2015_RD0817_14_14_20151117_00014.jpg

LM Start	1.28	Rating **	U	Issue No.	12
LM End	1.50	Issue Type +	Ma	Location *	LS
Category	Earthen Levee			GPS Latitude/Longitude	
				Start	End
Item	Vegetation			38.997019 °	38.999719 °
				-121.491802 °	-121.490147 °
DWR ID	DWR_RD0784_06_f _ 2012_12				
Action/Comments					
Remove the wild growth other than native grasses from the levee slopes. Inspector Comments: Vegetation picture is the same as the picture on the crown.

LM Start	1.28	Rating **	U	Issue No.	14
LM End	1.50	Issue Type +	Ma	Location *	CR
Category	Earthen Levee			GPS Latitude/Longitude	
				Start	End
Item	Vegetation			38.997019 °	38.999719 °
				-121.491802 °	-121.490147 °
DWR ID	DWR_RD0784_06_f _ 2012_14				
Action/Comments					
Remove the wild growth other than native grasses from the levee slopes.

View of the vegetation on the crown of the levee looking upstream. Fall 2015.

LM Start	1.28	Rating **	U	Issue No.	13
LM End	1.50	Issue Type +	Ma	Location *	WS
Category	Earthen Levee			GPS Latitude/Longitude	
				Start	End
Item	Vegetation			38.997019 °	38.999719 °
				-121.491802 °	-121.490148 °
DWR ID	DWR_RD0784_06_f _ 2012_13				
Action/Comments					
Remove the wild growth other than native grasses from the levee slopes.					
Inspector Comments: Vegetation picture is the same as the picture on the crown.
